LUXEMBURG – HERITAGE @ RISK!

Case Study 1 – Steinsel, damaged wayside cross

Case Study 2 – Rescue of a house

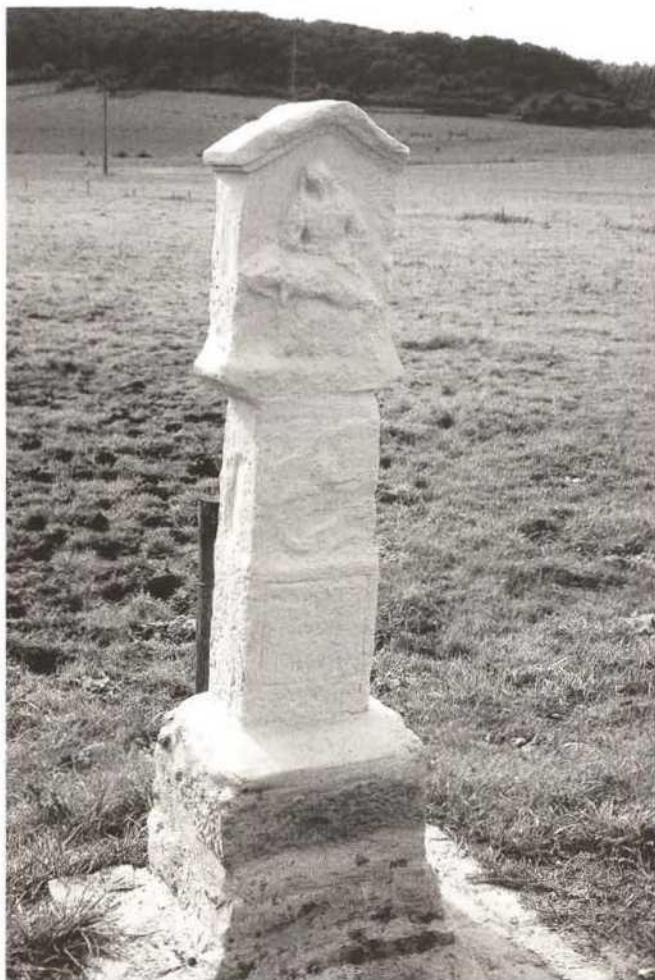
Recently, the Steinsel Council conducted the conservation of all its calvary crosses. The examination of the items revealed that some monuments are extremely damaged. The cross situated between Steinsel and Hunsdorf had practically lost all its sculptural relief and all its inscriptions. An iron bar fixed to the back had caused the erosion of several elements.

The holes have finally been plugged with the aid of reconstituted stone. To give a harmonious aspect to the feature and to protect the original sandstone, all of it has been covered with a coat of whitewash. That will need to be renewed regularly. It was not possible to recreate the legibility of the reliefs.

Steinsel, wayside cross after restoration

Récemment la Commune de Steinsel a fait procéder à la remise en état de tous ses calvaires. L'examen des pièces a révélé que quelques monuments sont fortement abîmés. La croix située entre Steinsel et Hunsdorf a pratiquement perdu tous ses reliefs et toutes ses inscriptions. Une barre en fer fixée à l'arrière avait provoqué l'effritement de nombreux éléments.

Les trous ont finalement été rebouchés à l'aide d'une pierre reconstituée. Pour donner un aspect harmonieux à l'ensemble et pour protéger le grès originel, le tout a été revêtu d'une couche de peinture à la chaux. Celle-ci devra être renouvelée régulièrement. La lisibilité des reliefs n'a pas pu être reconstituée.

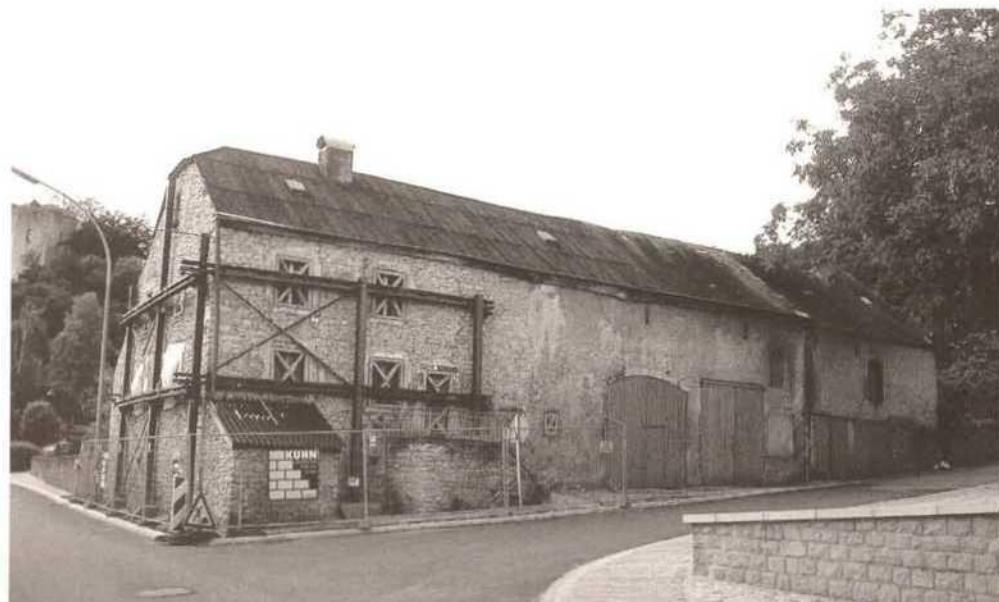
At Septfontaines, the bridges and roads authority, in collaboration with the local government, proceeded to straighten the main road in the village which is a national highway. As part of the scope of these works, it was expected to demolish a historic

house, whose current appearance dates back to the end of the 18th century. As the house had not been lived in for about twenty years, the interior had not been modified and maintained its original layout. However above all, the structure assumes a vital importance for keeping the social fabric of the village intact. It is after all located at the corner of a crossroads and is completely free-standing. Its disappearance would have created an empty space in the middle of the village. When the National Sites and Monuments Service got knowledge of this demolition project, it preceded to inscribe the building on the supplementary inventory of national heritage places. Negotiations were initiated between the authorities concerned and the owners. Eventually, the house, classified as a national monument in the meantime, was able to be saved. It is currently undergoing restoration. Sadly other villages have been disfigured by demolitions of this kind.

Septfontaines, rescue of a house threatened by road construction

A Septfontaines, l'Administration des Ponts et Chaussées, en collaboration avec l'Administration Communale, a procédé au redressement de l'artère principale de la localité qui est une route nationale. Dans le cadre de ces travaux était prévue la démolition d'une maison historique remontant, dans son aspect actuel, à la fin du 18^e siècle. Comme la demeure n'était plus habitée depuis une vingtaine d'années, l'intérieur n'avait pas été modifié et conservait sa disposition originelle. L'édifice revêtait cependant avant tout une importance capitale pour la conservation du tissu villageois. Il se situe, en effet à l'angle d'un croisement et est complètement dégagé sur tous les côtés. Sa disparition aurait créé un espace vide au milieu du village. Quand le Service des Sites et Monuments nationaux a eu connaissance du projet de démolition, il a fait procéder à l'inscription de l'immeuble à l'inventaire supplémentaire des monuments nationaux. Des pourparlers ont été entamés avec les administrations concernées et les propriétaires. Finalement, la maison, classée monument national entretenu, a pu être sauvée. Elle est actuellement en voie de restauration. Malheureusement d'autres villages ont été défigurés par des démolitions de ce genre.
