The 2002 Floods in the Czech Republic and their Impact on Built Heritage

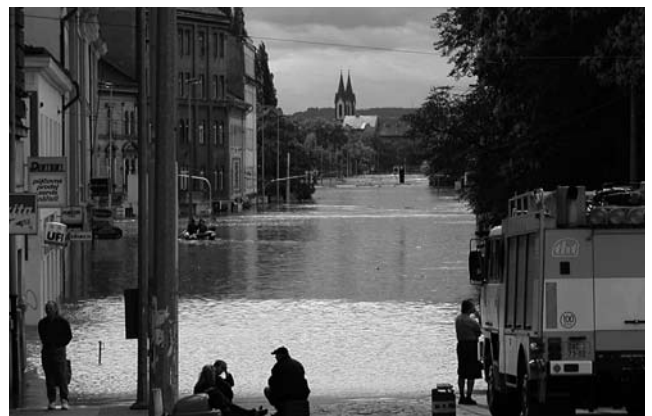
Fig. 2 Prague, Karlin. In the historical quarter St. Cyril and Methodius Church, an important work of neo-Romanesque architecture by Ignacius Ullmann, was flooded. Water rose there to a height of 1.6 meters, damaging the wall paintings and all movable objects.

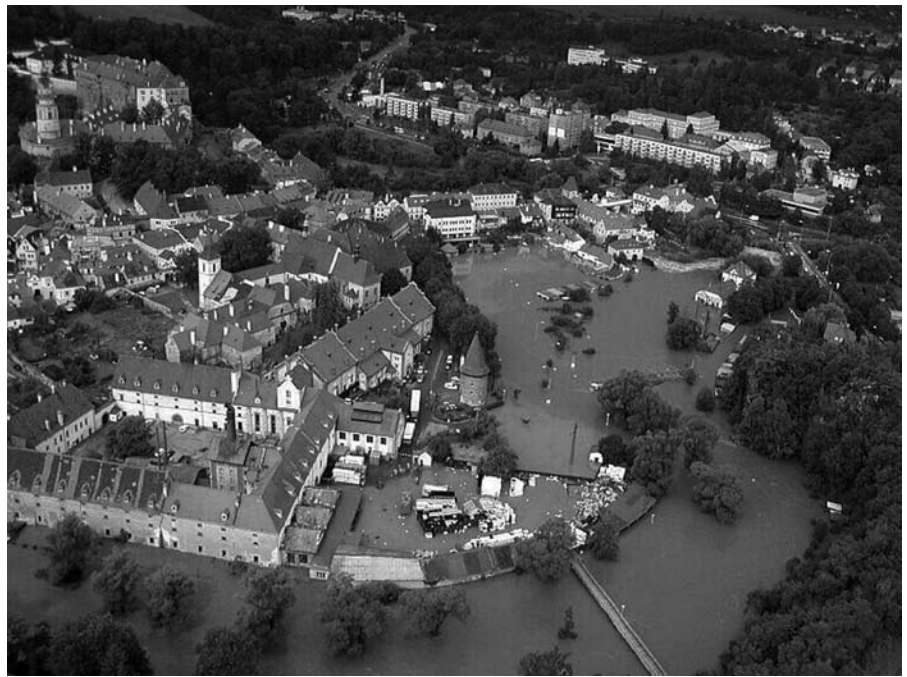
Fig. 3 Český Krumlov, historical centre of the Conservation Area. As one of the most complex town cores from the Gothic and Renaissance periods, it was listed on the UNESCO List of World Cultural and Natural Heritage in 1992.

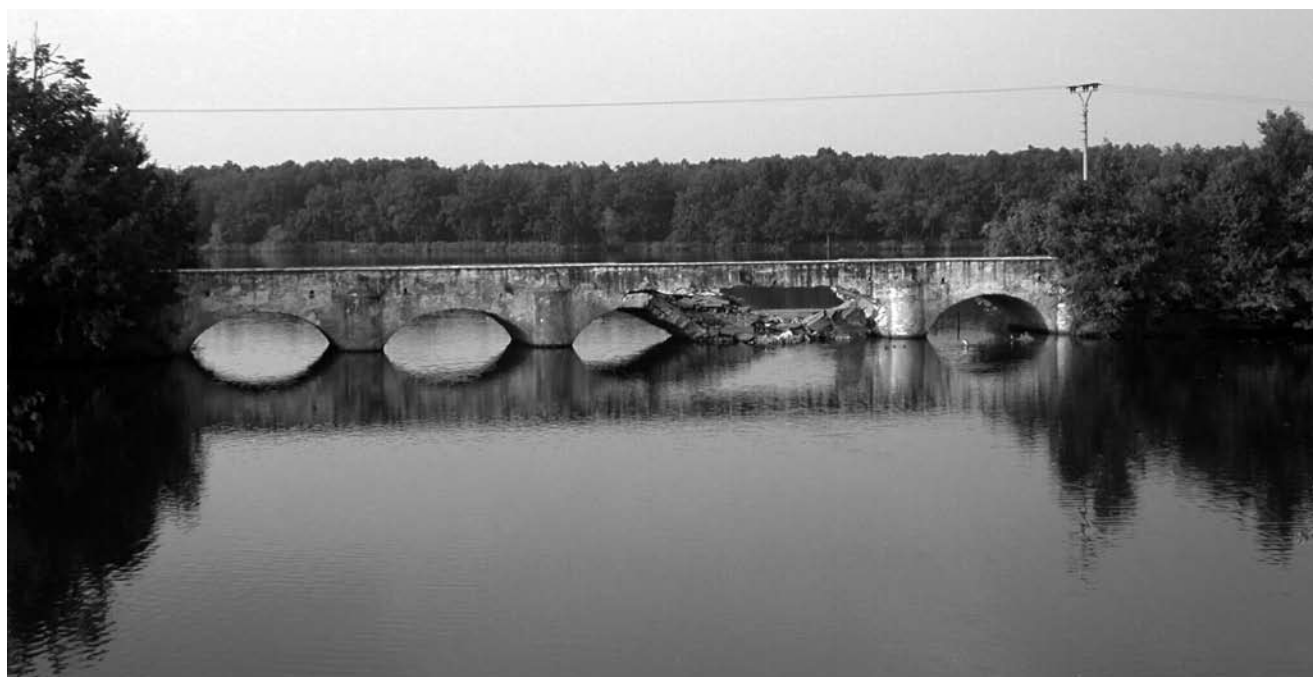
Fig. 4 Stará Hlína, the Inundation Bridge, a masonry bridge from 1781, historically located in the Třeboň pond system. Part of the bridge collapsed; it is necessary to reconstruct the bridge pillar as well as two bridge spans.

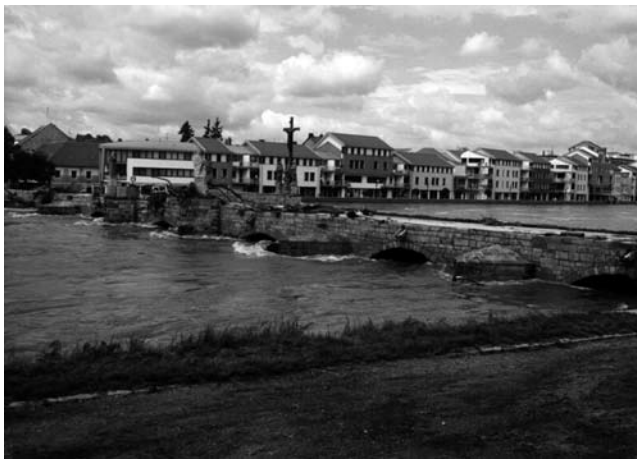
Fig. 5 Písek, the oldest medieval stone bridge in Bohemia from the period after 1250 with Baroque sculptural decorations. The bridge was completely under water, the breastwork walls made of granite square stones and one copy of the Baroque statues collapsed because of the flood.

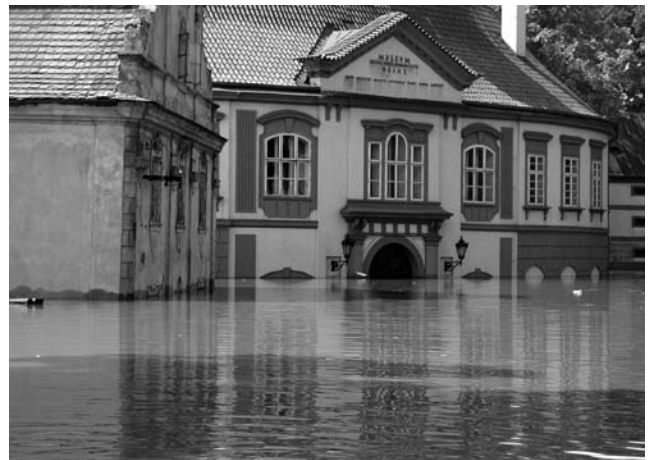
Fig. 6 Liběchov, historic country house and park, an important Baroque building by the excellent Czech architect F. M. Kaňka, built about 1730, with a park established in a formal style and decorated with numerous sculptures. The historic country house was flooded up to a height of 3.5 meters. Very valuable wall paintings by the well-known Czech painter Josef Navrátil are in critical condition. The valuable park was devastated and muddied.

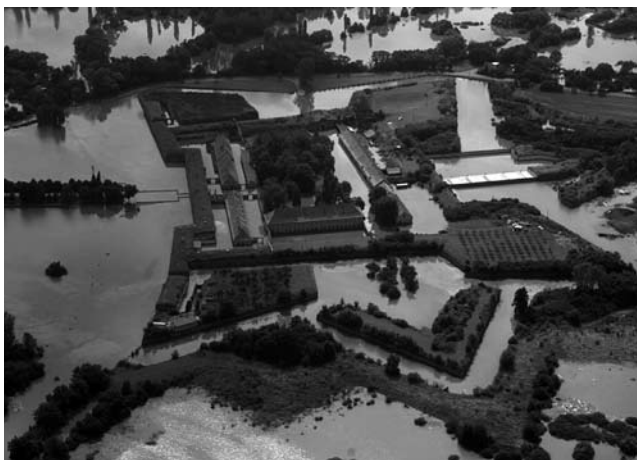
Fig. 7 Terezín, fortress. The original fortifications are based on Baroque fortification systems of the 17th century. During the August 2002 floods, Terezín and surroundings were flooded up to a height of 3 meters. The historically valuable underground protection system of the fortress was also badly damaged.

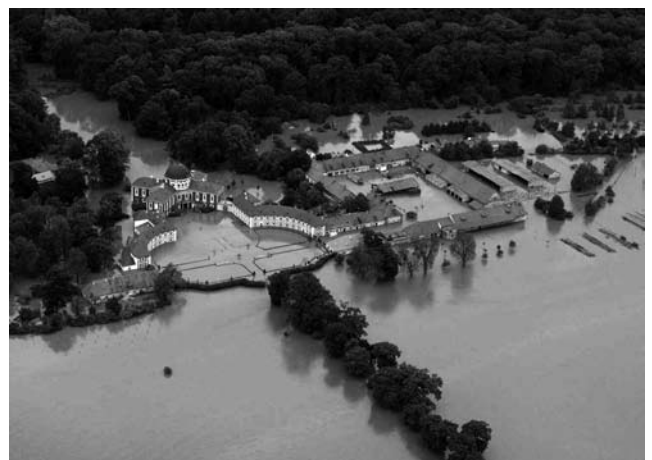
Fig. 8 Veltrusy, historic country house area and landscape park, an important work of the high Baroque period from the first half of the 18th century, probably designed by the important architect F. M. Kaňka or G. B. Alliprandi. The Veltrusy historic country house was flooded up to a height of about one meter. Interior plasterwork in the ground floor, wall paintings and valuable decorations in the sala terrena were damaged. The landscape park is completely destroyed

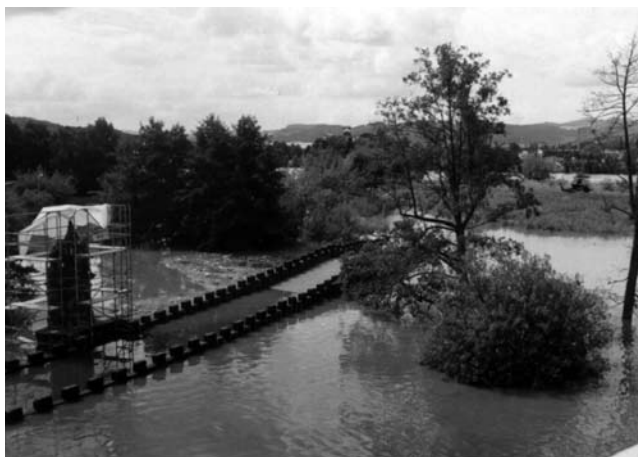
Fig. 9 Děčín, stone bridge in the late medieval Gothic style with a sculptural group of St. Vitus, St. John of Nepomuk and St. Wenceslas by the sculptor M. J. Brokof from 1714. One of the pillars was damaged by the flood and the bridge statics was affected.

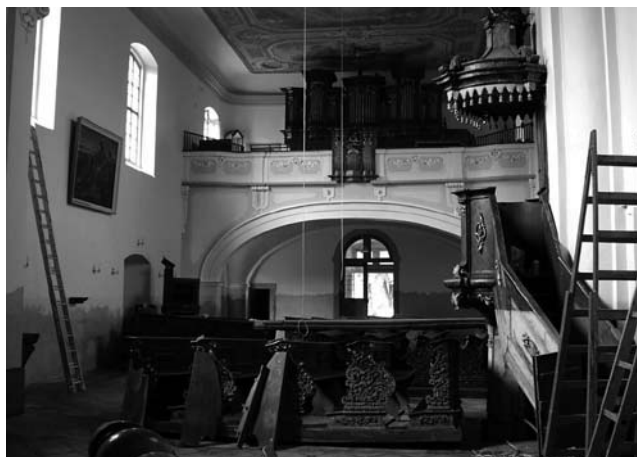
Fig. 10 Štětí, area of St. Simon and Juda Church, 1785. Church foundations at the sidewall were undermined; plasterwork, stone components and movable objects are damaged.
