The Urbieta Wreck (Gernika) Basque Country

Manuel Izaguirre

Center for Underwater Investigations INSUB

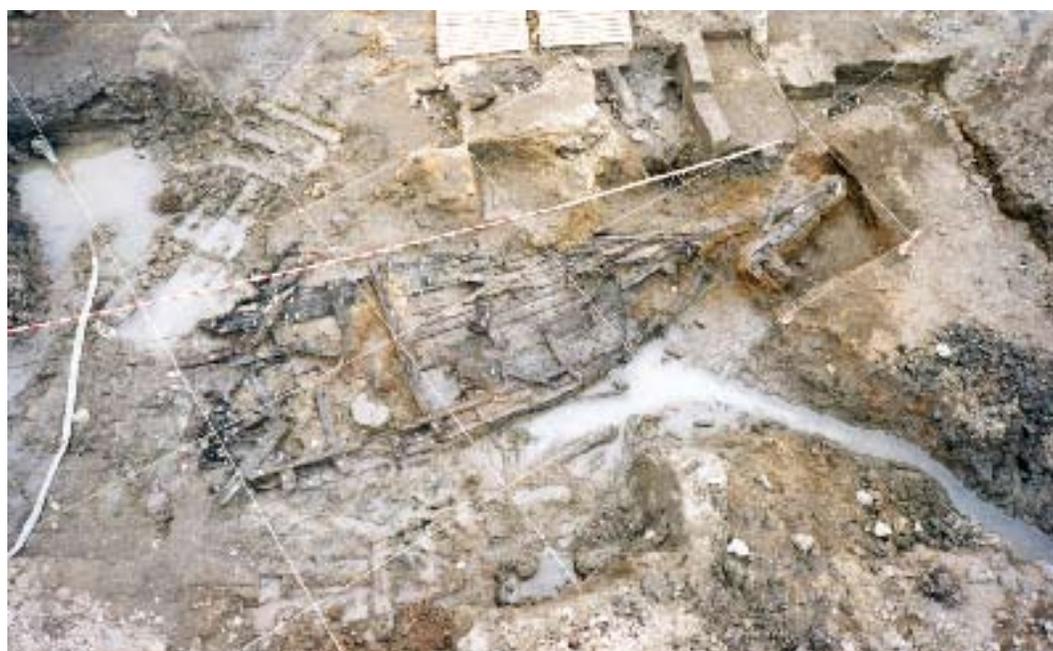
Figure 1: Aerial view of the dig; at the extreme right of the wreck is the stern and at the left is seen the transverse gap caused by the excavation equipment during the dredging of the Oka river

The central part of the vessel, along about one-third of its length had been destroyed by the backhoe excavator. While most of the solid pieces could be salvaged, many of the construction details of this part were lost such as the keelson and the

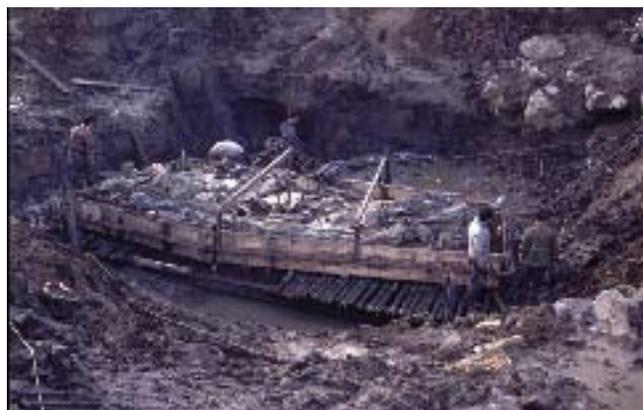
Figure 2: In order to extract the wreck from the silt of the river, it was required to detach it from the ground by creating a platform of horizontal tubes

To raise the vessel, the surroundings of the vessel were excavated up to a depth of 1.6m over a sufficiently wide area to obtain a horizontal plane that allowed the boring of transversal tunnelling holes and placement of a series of parallel horizontal tubes under the vessel. Taking into account the irregularity of the mud and sand under the boat, a blocking fence was built around the structure using wooden boards and a metal structure to a height of 60 cm.

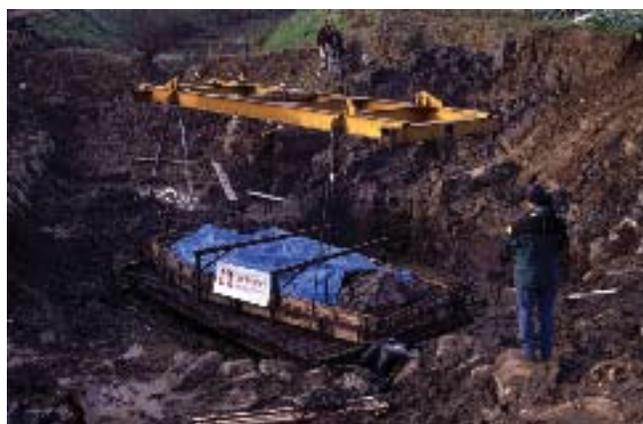
Figure 3: Once detached from the silt, it required a large crane to lift the block of the wreck onto the bed of a special truck of adjustable height

The horizontal layer of tubes thus created also served as a base for the earthen block on which the vessel was resting. Once this was reinforced by the metal structure, it was extracted using a heavy-duty crane and placed onto a truck/lorry of adjustable height, which transported the whole block to a temporary storehouse near the location of the find.

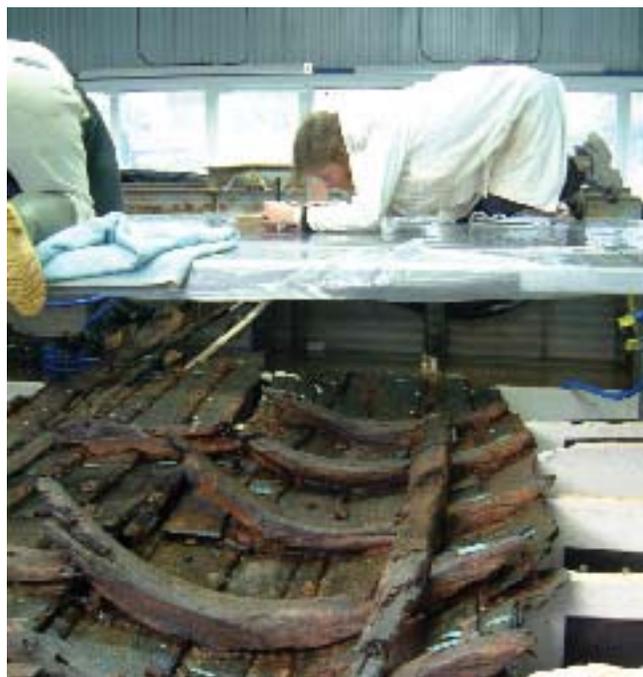
Figure 4: After a careful cleaning of the wreck, the details and design of the archaeological remains were recorded, indispensable for the recreation and elaboration of the real and hypothetical forms of the architecture of the boat
