ORANGERIES IN SWEDEN

SUMMARY

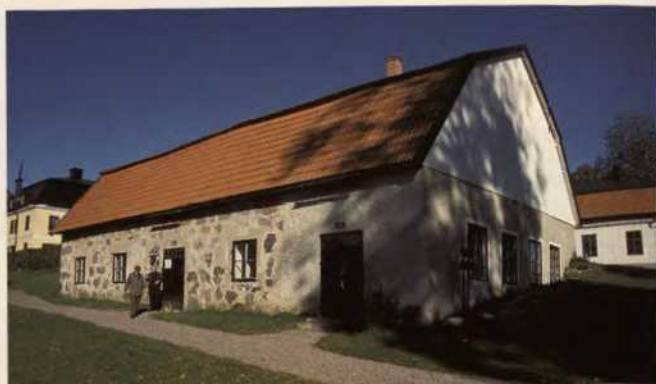
Fig. 1 The right part of this 17th century cellar has been used for keeping plants during the winter. Sätuna, Uppland. Photo: Ingela Andersson, 2000

A few orangeries from the 17th century are known. They are called by different names: "örtahus" (herbhouse), "orange hus" (orange house) or "pomeranshus" (bitter orange house). The best known were built by Olof Rudbeck the elder in the botanical garden in Uppsala. The "pomeranshus" (bitter orange house) he built was dismantled. He also constructed orangeries for the manor houses Jacobsdal (now Ulriksdal), Karlberg, Mörby and Venngarn.² All of these orangeries are long gone. Cellars were also used for overwintering of plants. One such cellar is still preserved at the manor house of Sätuna (Figure 1).

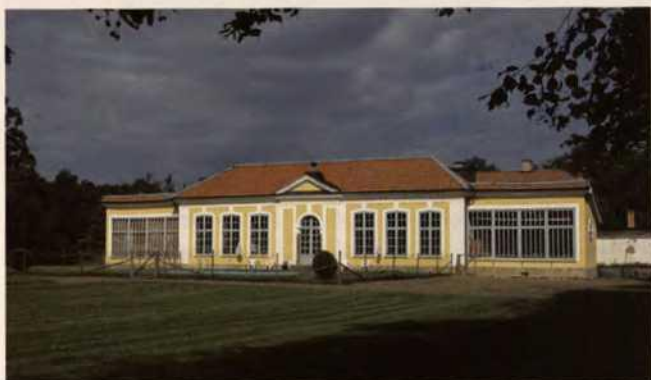
Fig. 2 Orangery at Sturefors, Östergötland, built in the early 18th century. The architect was probably Nicodemus Tessin the younger. Photo: Ingela Andersson, 2001

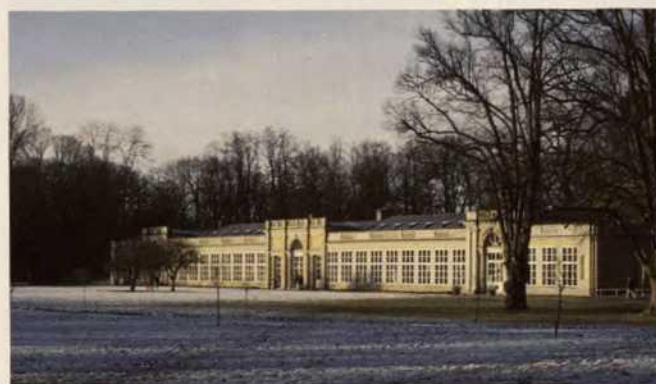
Fig. 3 Orangery at the royal palace Ulriksdal, Stockholm, erected around 1700, architect: Nicodemus Tessin the younger, today a museum for sculptures. Photo: Ingela Andersson, 2001

Most of the orangeries in Sweden were built during the 18th century. Orangeries then became popular not only with the king, his closest men or with botanists as had been the case in the centuries before. Now other noblemen wanted to have orangeries of their own. A few orangeries from around 1700 and the first half of the 18th century are still preserved. At Runsa, Sturefors (Figure 2), Ulriksdal (Figure 3) and Lövsstabruk (Figure 4) there are orangeries that by and large date back to this time.

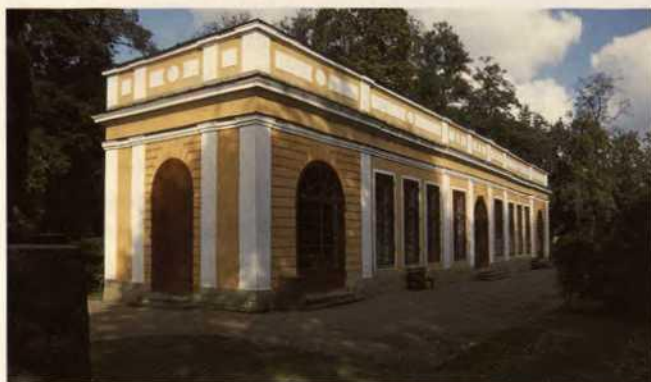
Fig. 4 Orangery at Lövestabruk, Uppland, first erected around 1700 but probably changed by the middle of the 18th century. This orangery is the best preserved in Sweden. Photo: Ingela Andersson, 2000

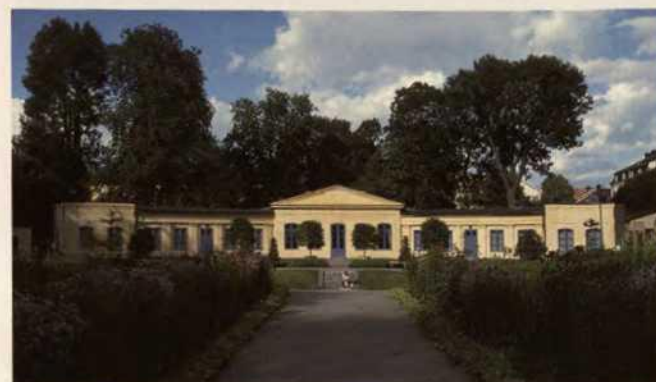
Fig. 5 Orangery in Carl von Linné's botanical garden, Uppsala, erected in 1742-43. Architect: Carl Hårleman. Photo: Ingela Andersson, 2000

The well known botanist Carl von Linné introduced more advanced orangery cultivating methods. His orangery was built in Uppsala in 1742-43 (Figure 5). He divided his orangery into three different rooms. Each with a different climate: frigidarium (cold room), tepidarium (temperate room) and caldarium (warm room). This idea of different climate zones was not commonly in use in Sweden until the following century.

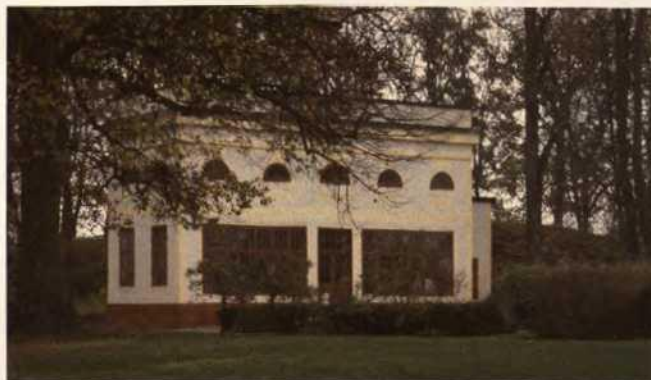
Fig. 6 Orangery at Lagmansö, Södermanland, erected in 1777. Architect: Fredrik Wilhelm Hoppe. Photo: Ingela Andersson, 2000

Examples of orangeries from the last half of the 18th century are still to be found at Lagmansö (Figure 6), Gimo (Figure 7), Stora Skuggan (Figure 8) and Säby. In the early 19th century orangeries were still being built in about the same

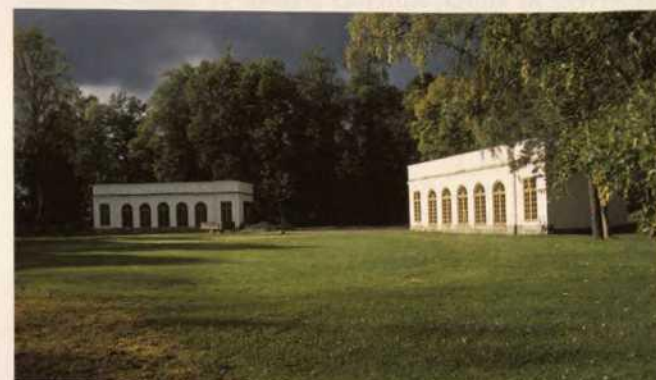
Fig. 7 Orangery and forcing house at Gimo, Uppland, erected in the 1770s. Photo: Ingela Andersson, 2000

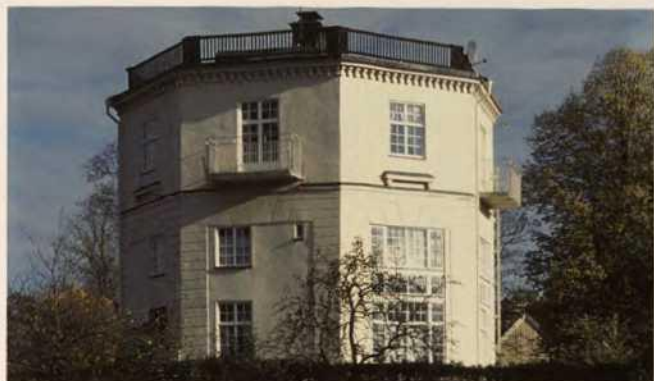
Fig. 8 Orangery at Stora Skuggan, Stockholm, used for palmtrees, built between 1796-99. Archibect: Jean Louis Desprez or Fredrik Magnus Piper. Photo: Ingela Andersson, 2001

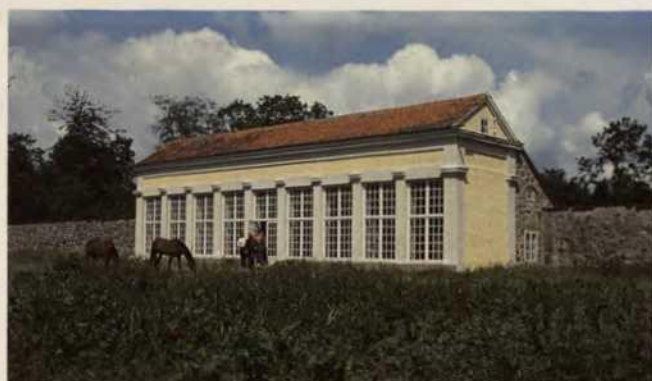
Fig. 10 Orangery at Löberöd, Skåne (Scania), erected in 1811. Photo: Ingela Andersson, 2003

type of architecture. Towards the middle of the century they were used for both overwintering of plants and forcing. Some examples of the early type of orangeries can be found at Löberöd (Figure 10) and Haneberg (Figure 11).

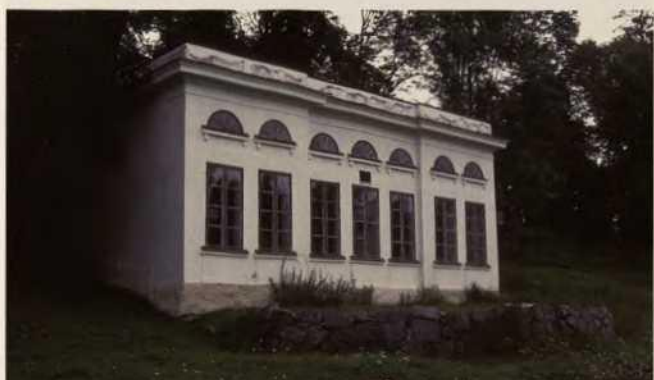
Fig. 11 Orangery at Haneberg, Södermanland, built in 1814. Photo: Ingela Andersson, 2000

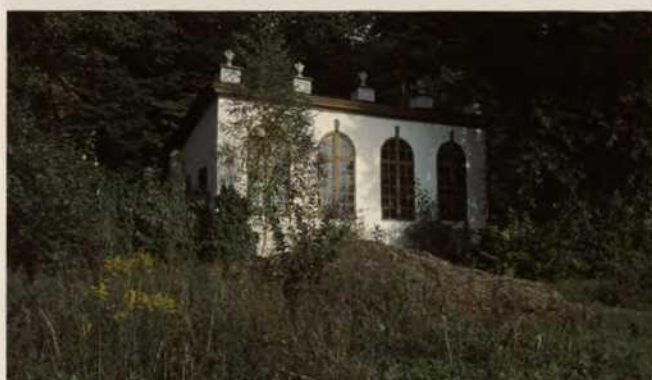
Fig. 12 Orangery at Norsborg, Stockholm, containing an apartment for the gardener (the two blind windows to the right), erected in the 1790s. Photo: Ingela Andersson, 2001

Orangeries in Sweden were not always built in brick. In forest areas timber was used for building both orangeries and other types of forcing-houses like vineries and peach-houses. A few of them are still preserved. They mainly date from the late 18th and the early 19th centuries and can be found at the manor houses of Norsborg (Figure 12), Eka (Figure 13), Regnholm (Figure 14) and Stola (Figure 15).

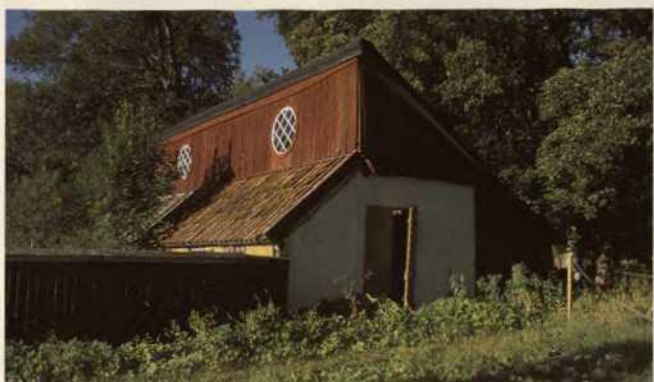
Fig. 13 Orangery/greenhouse at Eka, Uppland, partly a half-timbered house and partly wooden, probably built in the early 19th century. Photo: Ingela Andersson, 2000

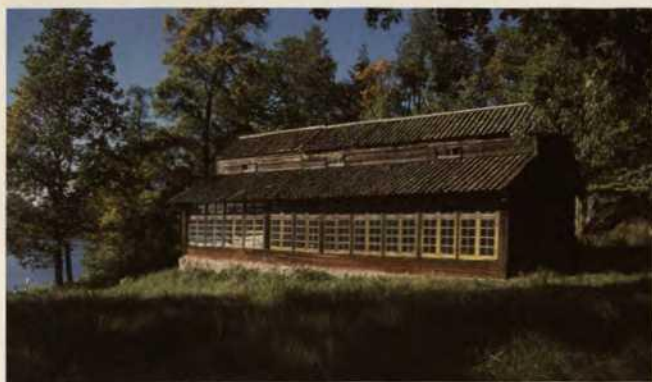
Fig. 14 Timber orangerie/forcinghouse at Rengabholm, Östergötland, originally with a lower glass roof, erected some time before 1828. Photo: Ingela Andersson, 2000

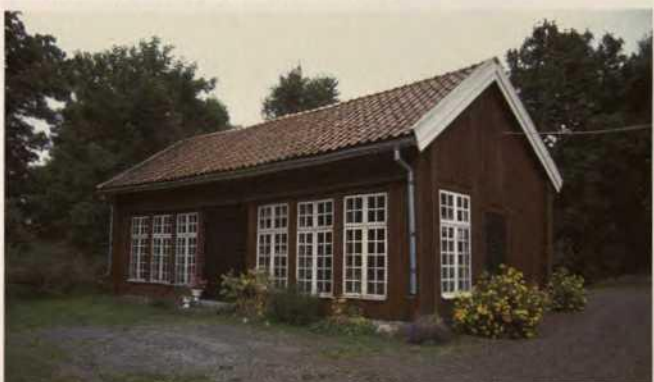
Fig. 15 Orangerie at Stola, Västergötland, with the typically Swedish wooden house colours red and white, probably built in the 19th century. Photo: Ingela Andersson, 2001

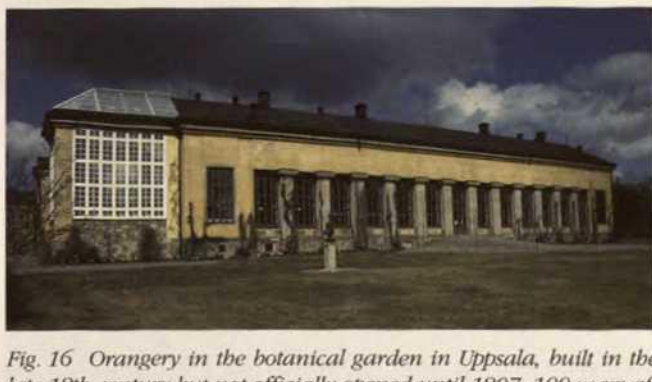
Fig. 16 Orangery in the botanical garden in Uppsala, built in the late 18th century but not officially opened until 1807, 100 years after the birth of Carl von Linné. The only orangery in Sweden still fully in use for its original purpose, containing among other plants some laurel trees from the time of Linné. Photo: Ingela Andersson, 2000

Towards the end of the 18th century an orangery was built in the new botanical garden situated in the garden of Uppsala castle. This is the only orangery in Sweden still fully used for its original purpose (Figure 16).

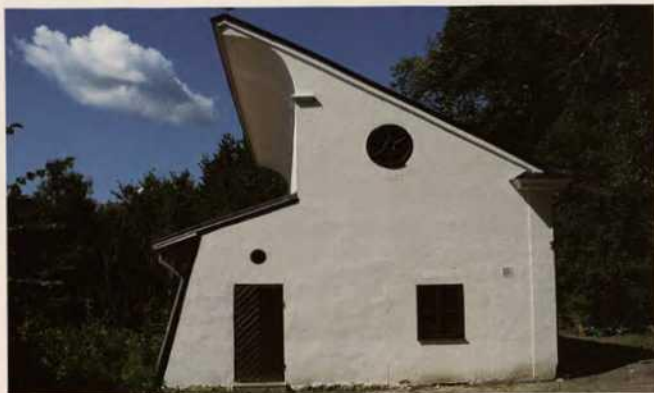
Fig. 17 "Swan-neck" orangery at Bernshammar, Västmanland, built between 1796-98. Photo: Ingela Andersson, 2004

By the end of the 18th century a few orangeries with 'swan necks' were built. The best preserved example can be found at Bernshammar (Figure 17). Also the forcinghouse (drivhus) at Stora Wäsby (Figure 18) has a swan-neck. This was probably erected earlier than Bernshammar.

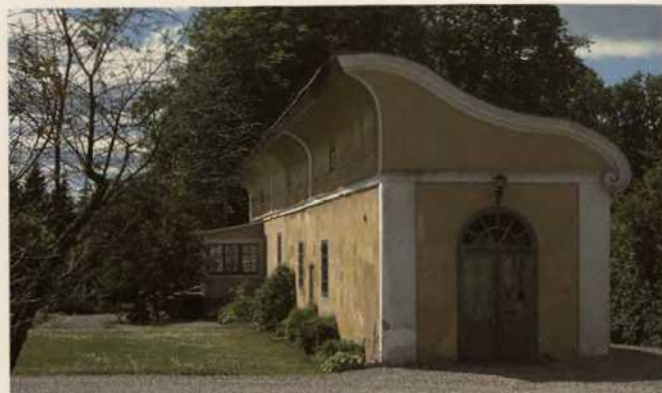
Fig. 18 Forcing house at Stora Wäsby, Stockholm, probably built in the late 18th century. Photo: Ingela Andersson, 2001

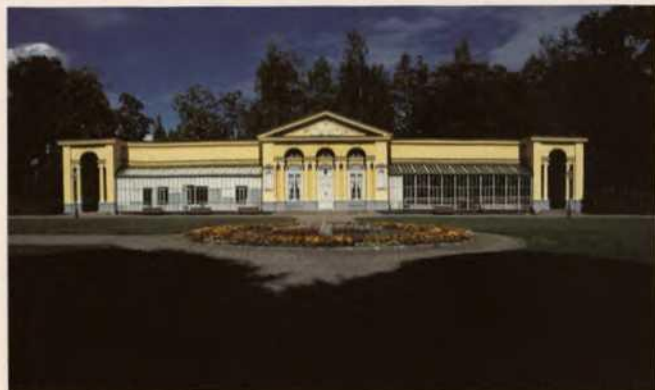
Fig. 19 Orangery/greenhouse at Finspång, Östergötland, finished in 1832 replacing an older orangery. Architect: Lars Jacob von Röök. Photo: Ingela Andersson, 2000

Towards the middle of the 19th century the combination of overwintering and forcing became more common in the architecture of the orangery/glass-houses. The tall middle section was used as orangery or wintergarden and the glass-houses at the sides were used for forcing plants or growing vines and/or peaches. The first two examples from Finspång (Figure 19) and Örbyhus (Figure 20) were erected in the 1830s. The other examples can be found at the royal palace of Tullgarn (Figure 21), at Eriksberg (Figure 22) and the royal castle of Gripsholm (Figure 23). As late as at the beginning of the 20th century a beautiful orangery of this kind was erected at Adelsnäs (Figure 24).

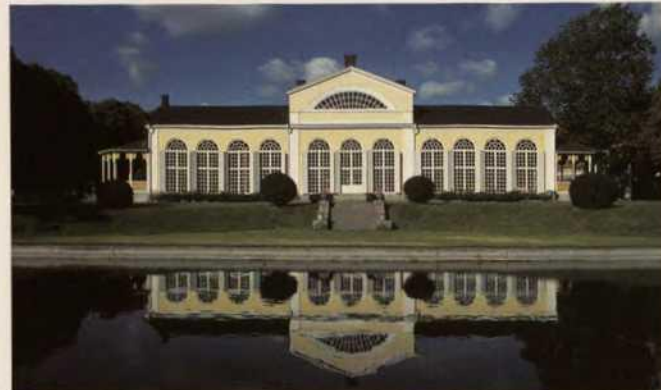
Fig. 20 Orangery at Örbyhus, Uppland, erected between 1832-33, partly used as a winter garden. Architect: Carl Christoffer Gjörwell. Photo: Ingela Andersson, 2000

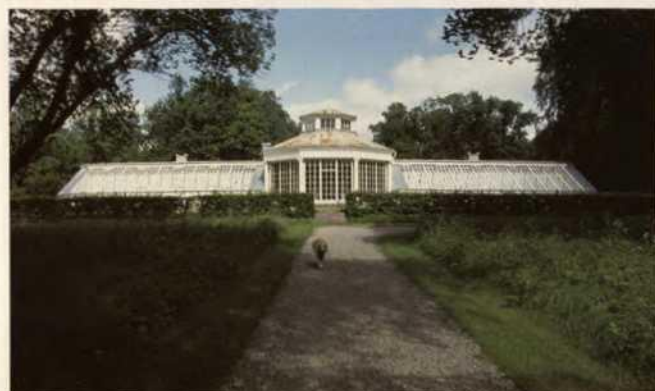
Fig. 21 Orangery at the royal palace Tullgarn, Stockholm, erected between 1853-56. Architect: probably George T. Chiewitz. Photo: Ingela Andersson, 2001

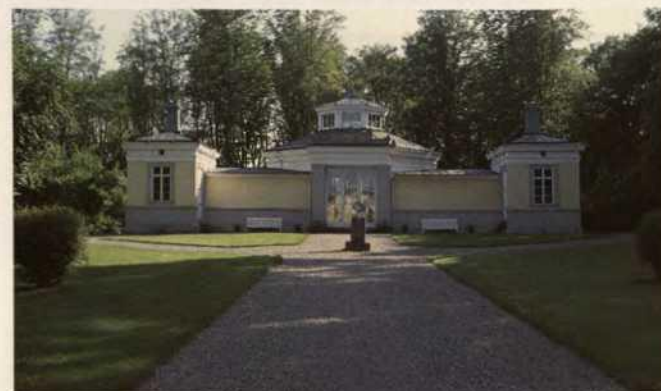
Fig. 22 Orangery at Ericsberg, Södermanland, erected in 1856. Photo: Ingela Andersson, 2000

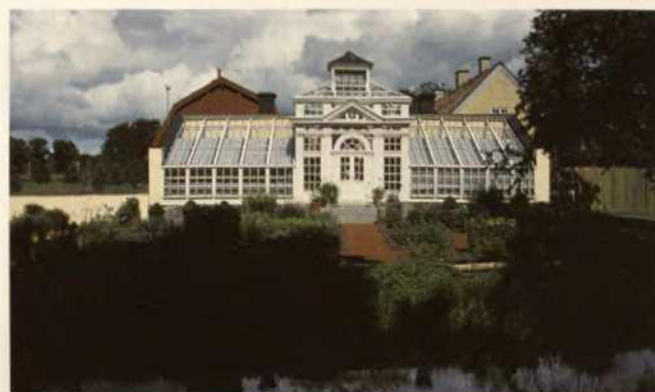
Fig. 23 The recently (1996) reconstructed orangery/forcing house at the royal castle Gripsholm, Södermanland, built 1892-98. Architect: Fredrik Lilljekvist. Photo: Ingela Andersson, 2001

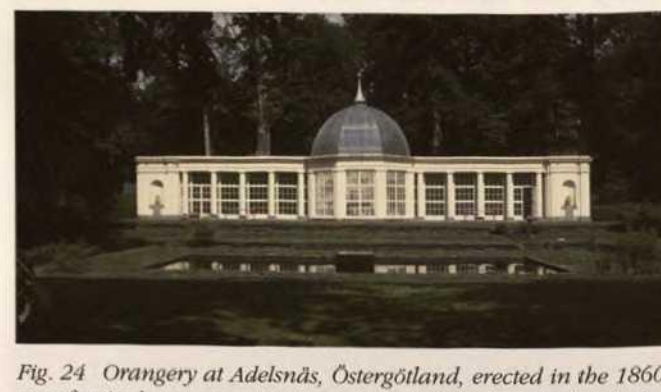
Fig. 24 Orangery at Adelnäs, Östergötland, erected in the 1860s as a forcinghouse, now used as an art gallery. The steel and glass cupola was kept when it was remodeled into an orangery in 1916. Architects: C. E. Ferngren (1860's) and Isak Gustaf Classon (1916). Photo: Ingela Andersson, 2000
