Report on Salvaging Rock Fragments, 2005

Western Buddha

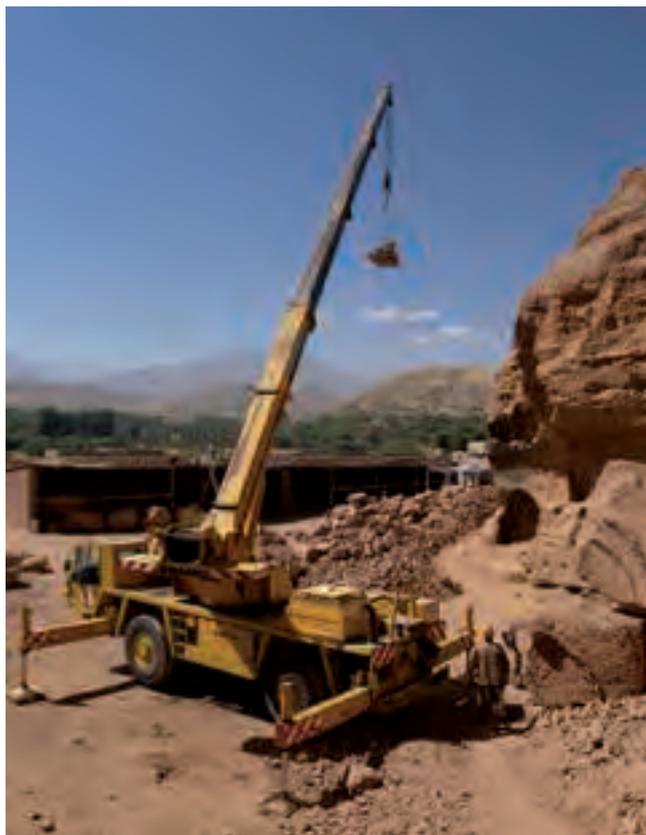
Recovery of rocks by means of a 35 t heavy-duty-crane at the Western Buddha

So far, at the Western Buddha more than 100 rock fragments with clearly recognizable sculpted surface have been recovered. These stones weighing up to 30 tons were deposited in the shelters. The large pieces were put on scantlings, the smaller ones on wooden pallets made by carpenters in the Bamiyan bazaar. The smaller stones without any recognizable surface as well as the sand are deposited at

an acclivity in the north-western area of the fenced-off terrain, to the left of the Buddha niche. After the recovery the rock fragments are numbered, documented photographically and in writing and – if appropriate – stored in one of the shelters. Depending on the weight of the rocks polyester heavy-duty belts and steel ropes with wooden interlayers are used for the transport with a crane. The Afghan workers exposed the rock fragments layer by layer by putting one shovel of sand after the other into a wheelbarrow. In this process the material was always checked for finds, such as parts of the clay surface, wooden pieces, etc. These special finds were collected and stored in the shelves of the ICOMOS office.

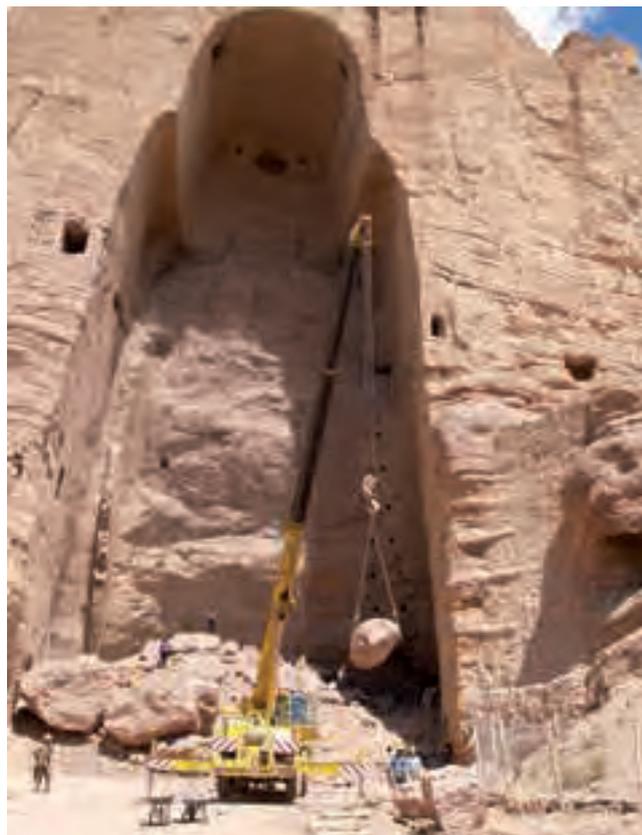
The shelters at the Western Buddha from above. The roof is partly open to lift Buddha fragments into the shelter by means of a crane.

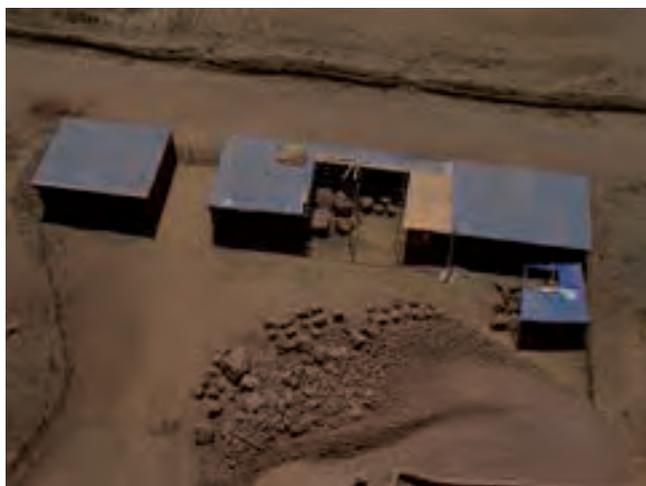
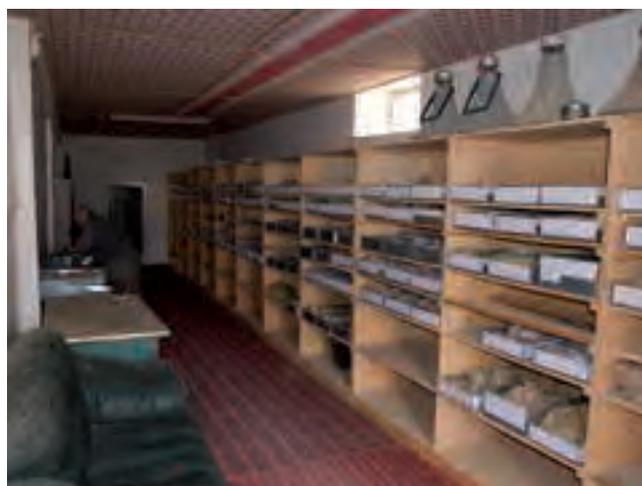
Shelves in the ICOMOS office for the storage of finds

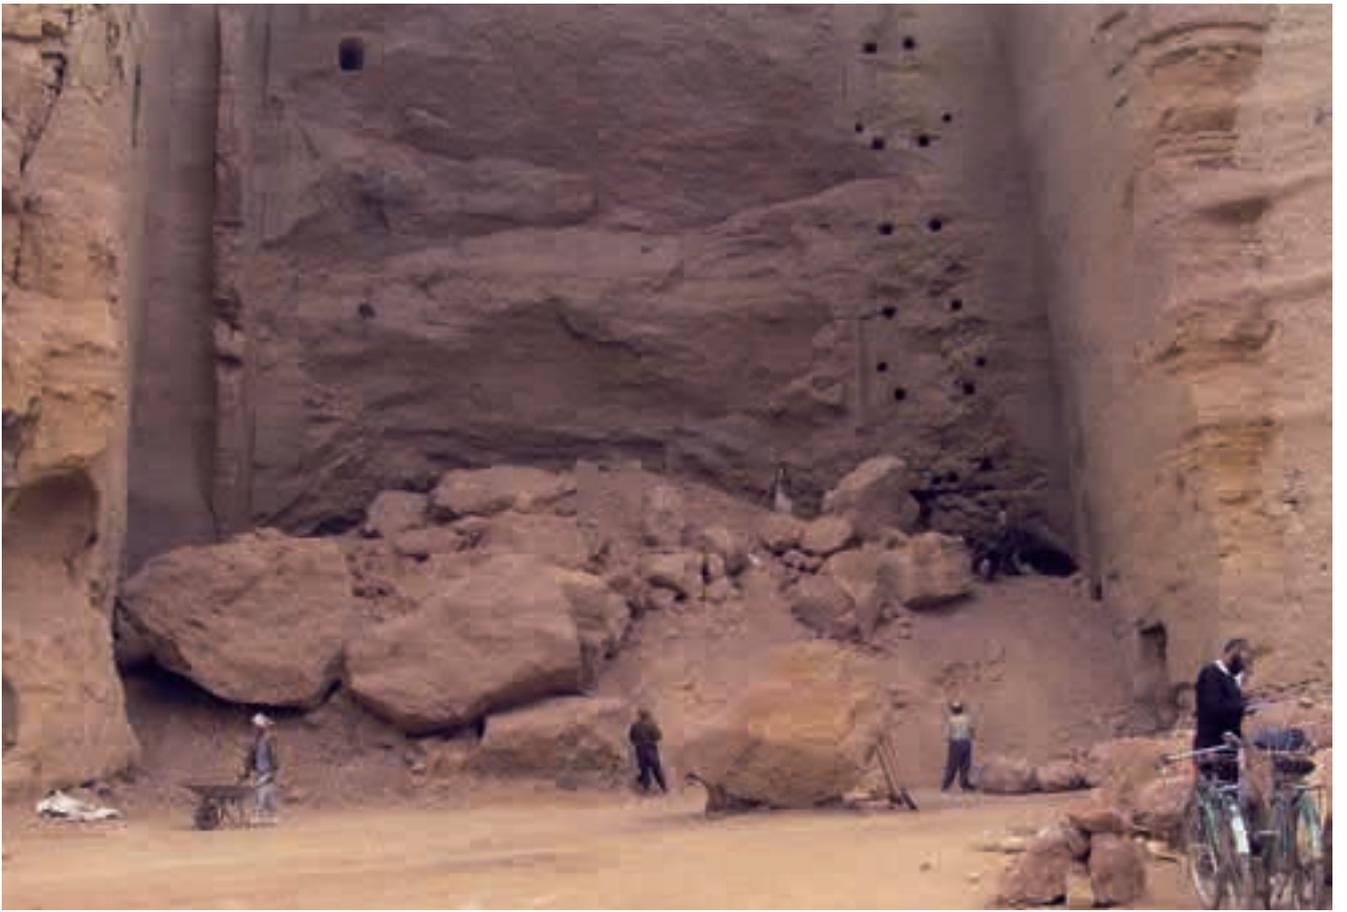
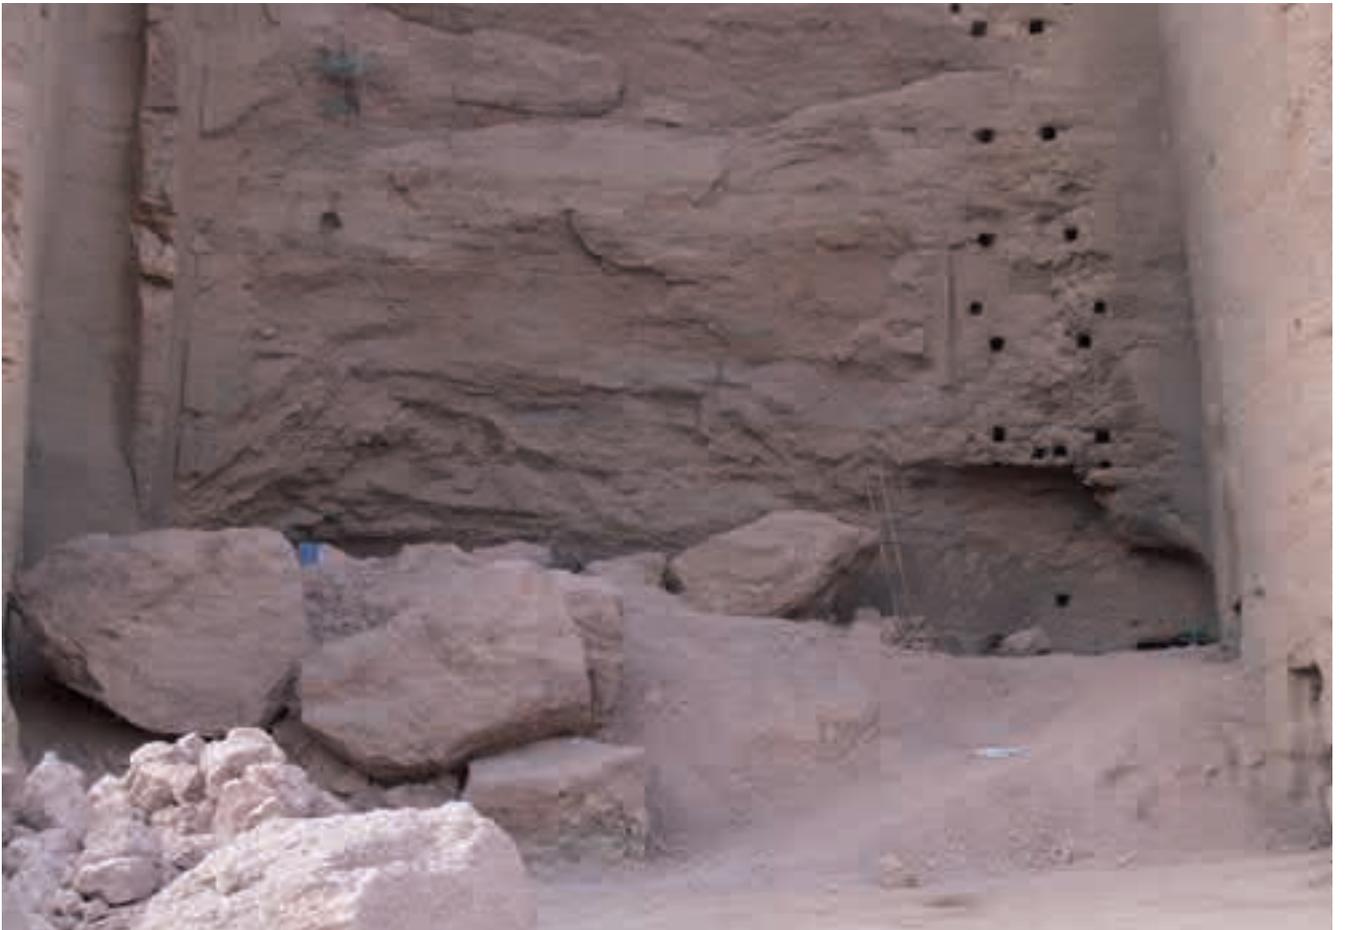
△ ▽ Progress made in salvaging the fragments of the Western Buddha in 2005

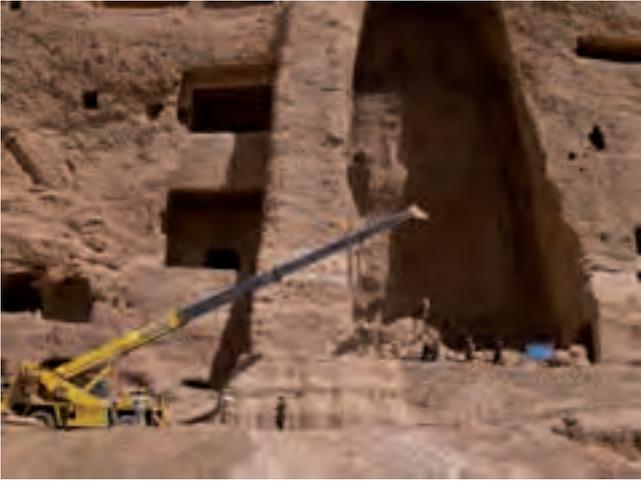
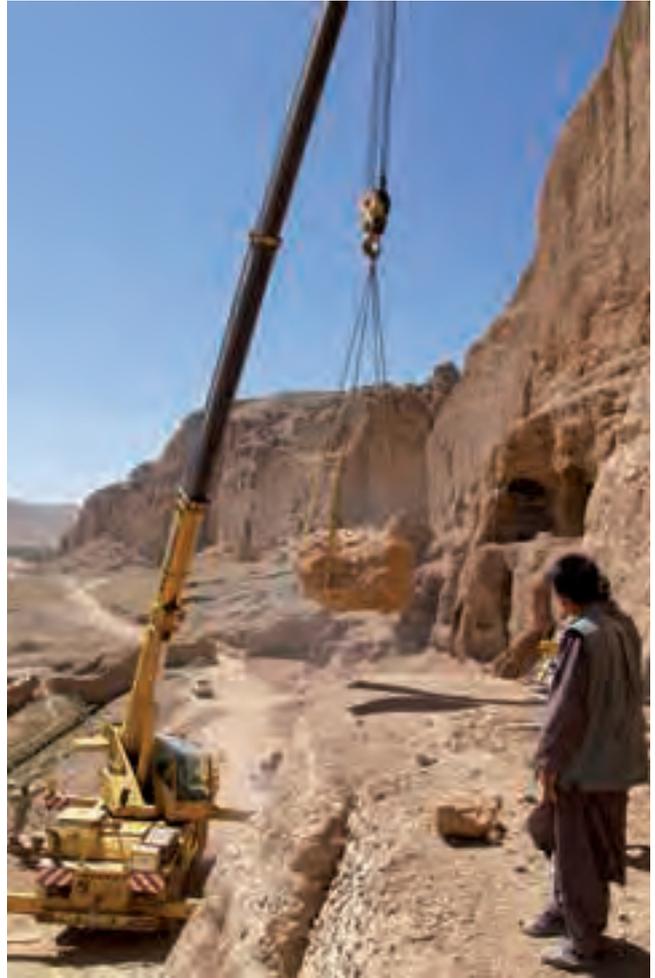
△ The crane lifting fragments from the upper platform of the Eastern Buddha niche ▷

It was not possible to position the crane in the centre immediately in front of the niche. West of the platform the base for the crane was enlarged and levelled. Half beams put under the crane arms improved the stability of the crane. Thus, the crane could almost reach the entire platform surface in front of the Buddha niche.

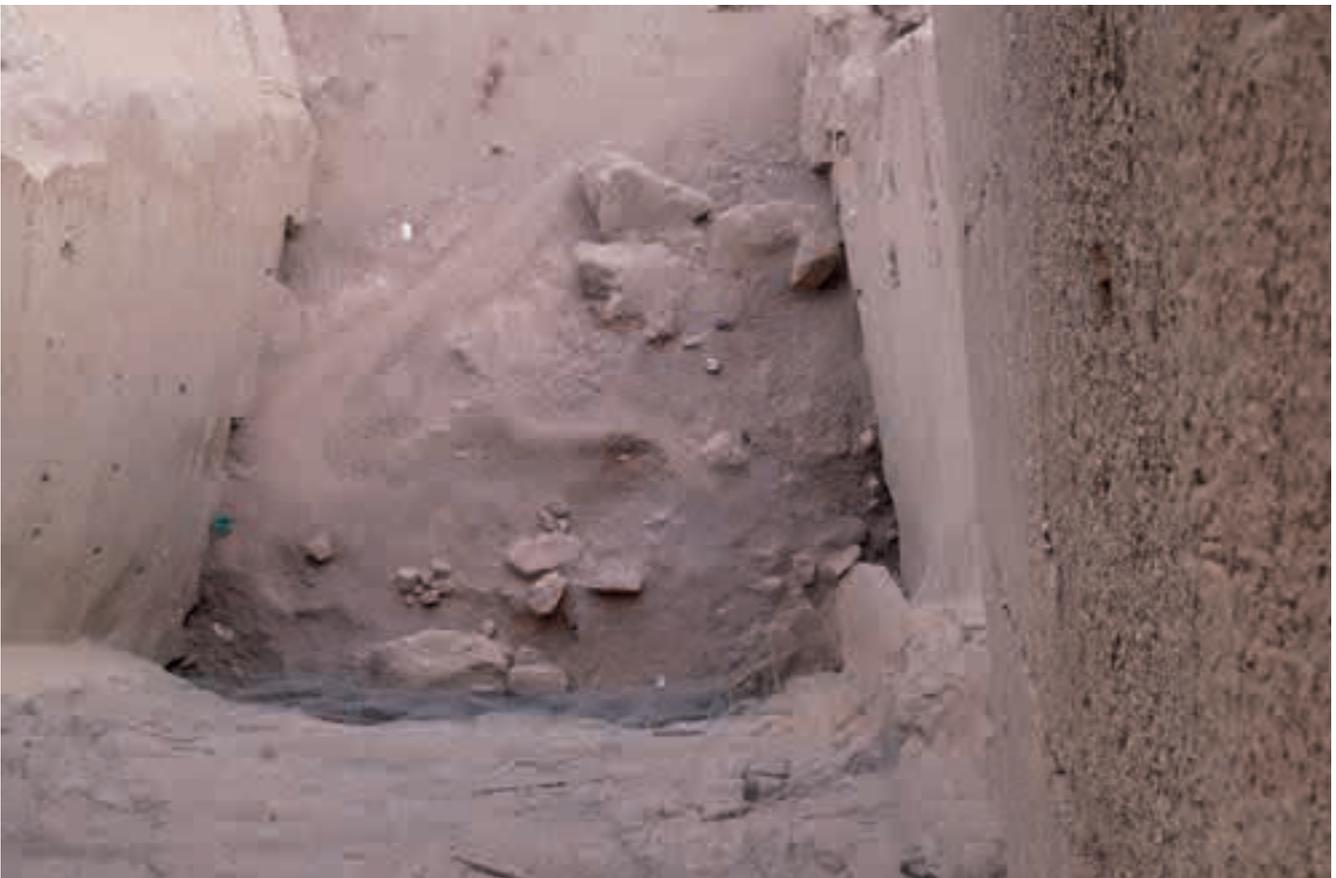
▽ The Eastern Buddha niche from above

In 2005, the salvage of fragments also began at the Eastern Buddha. The situation at the Eastern Buddha is much more difficult as the slope drops relatively steeply, only leaving a small bricked-up platform of three metres depth in front of the Buddha niche. A wheel loader can only just drive on that platform. The access road is narrow and unpaved. In the niche manual work was therefore predominant.

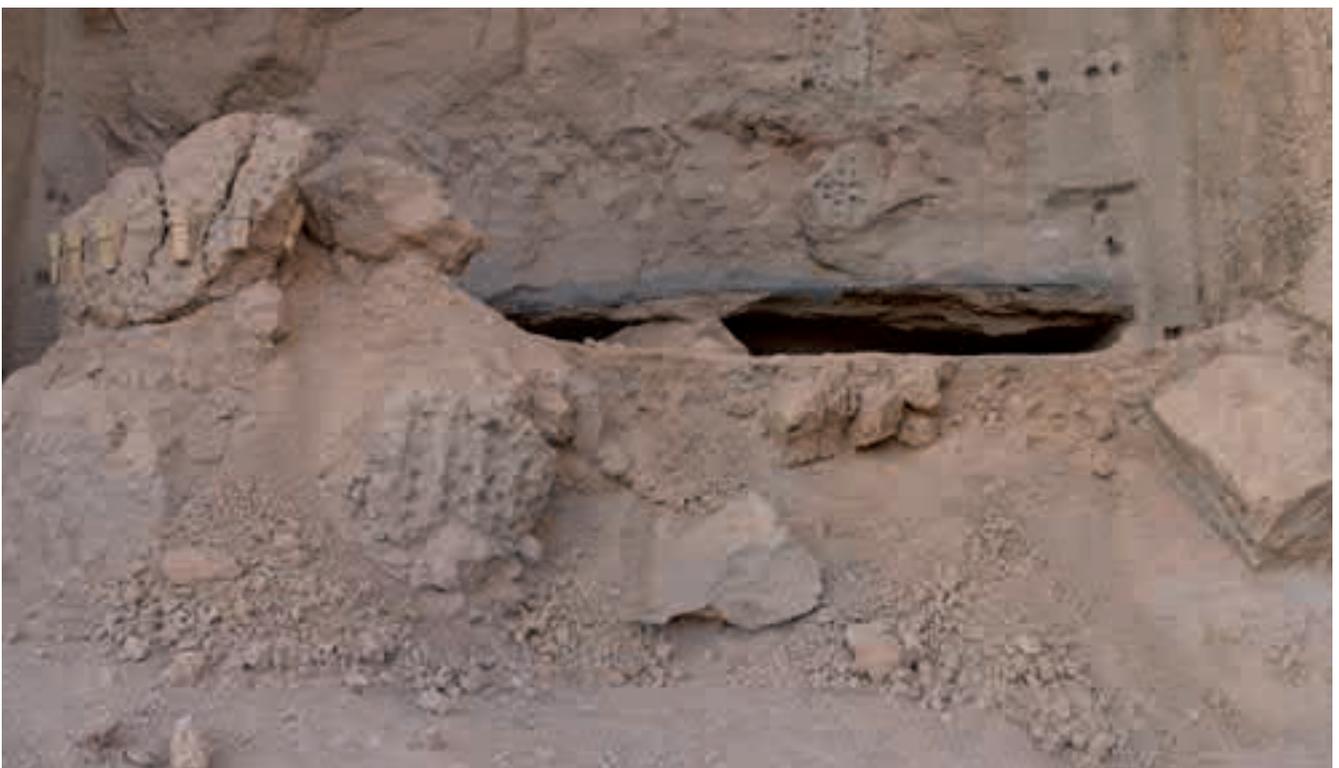
State of the Eastern Buddha niche on 6 September 2005: more and more rock fragments appear in the rubble

So far, up to 160 rock fragments have been recovered from the Eastern Buddha niche. Another problem at the Eastern Buddha was the lack of shelter space. For the storage of the sand drain fleece was laid out six metres beneath the path on a terrace, and with the gravel material of the surrounding area an enclosing wall on the valley side was erected. Using a chute the recovered sand could be stored here. In the west, inside the enclosing wall and to the left and right of the gateway additional storage space was laid out. As an interim depot a widening of the path to the west and beneath the platform and the niche was chosen. These areas were fenced off, walled in and roofed.
